TUNNEL IDENTIFICATION AND DESCRIPTION

INSPECTION TEAM: T. Suthers, J. Wolfe (Burgess & Niple, Inc.)

FIELD INSPECTION REPORT**STRUCTURE NO. 8-8****INSPECTION DATE: 12/13/05**

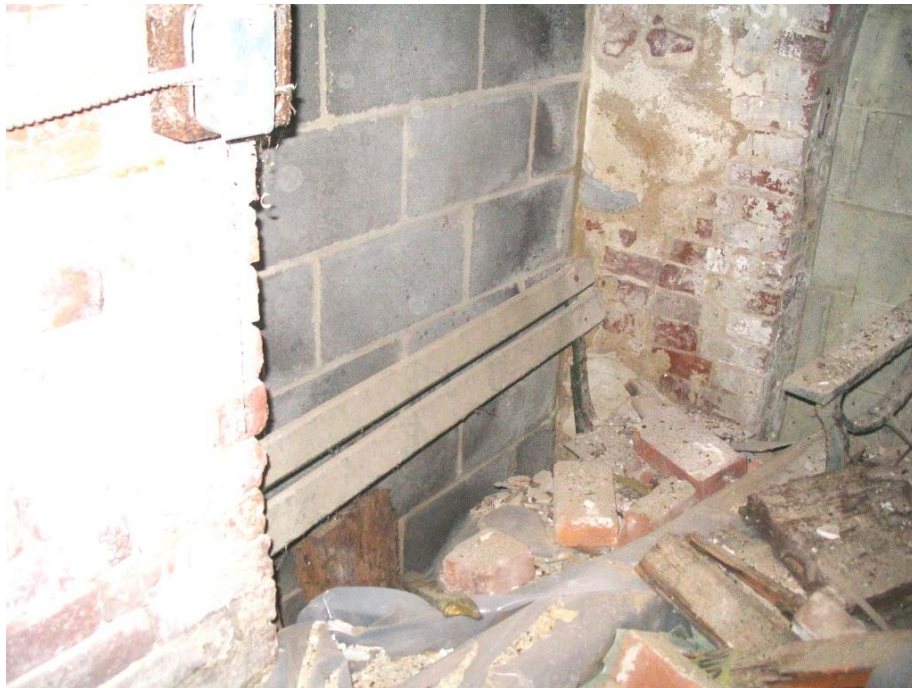
Photo 2: West portal, east side

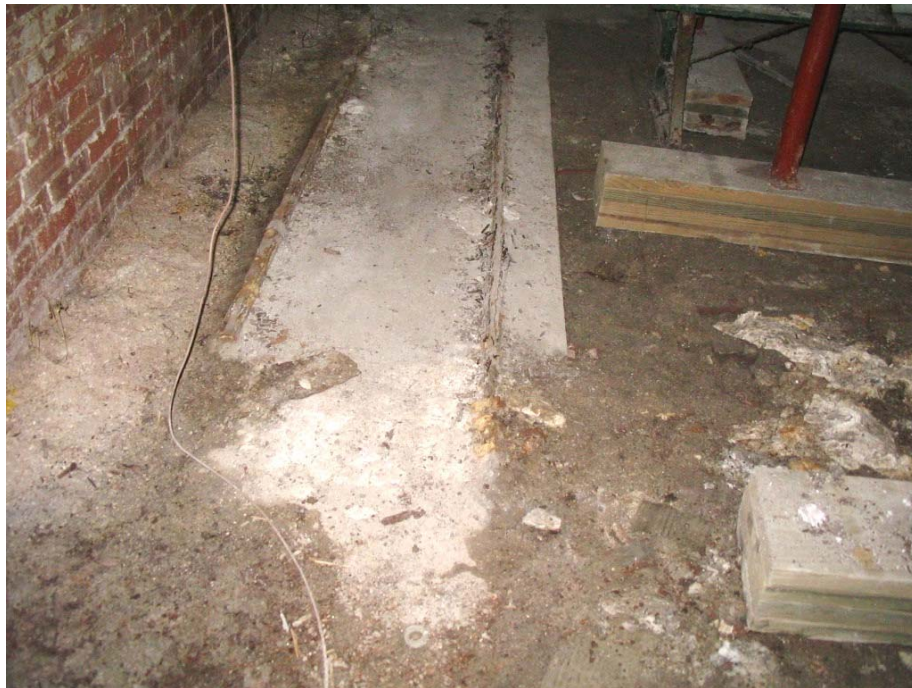
Photo 4: East end of rails; Note debris on floor and hanging telephone wire

1. Remove debris from floor, 2 CY.
2. Replace electric lines, 80 LF.
3. Replace lighting conduits and wiring, 80 LF.

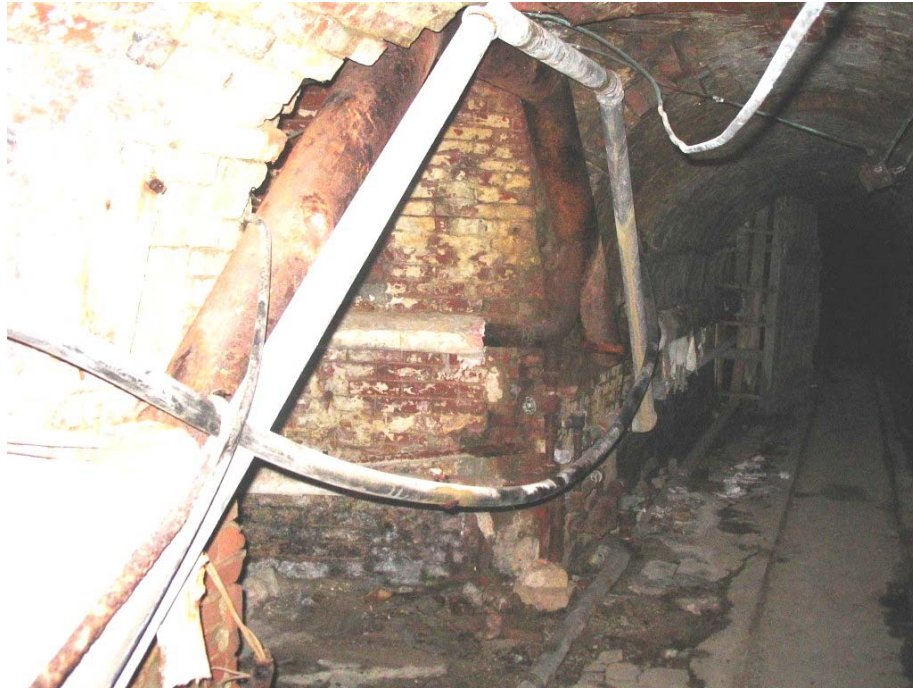
Photo 1: North portal; Note chipped bricks

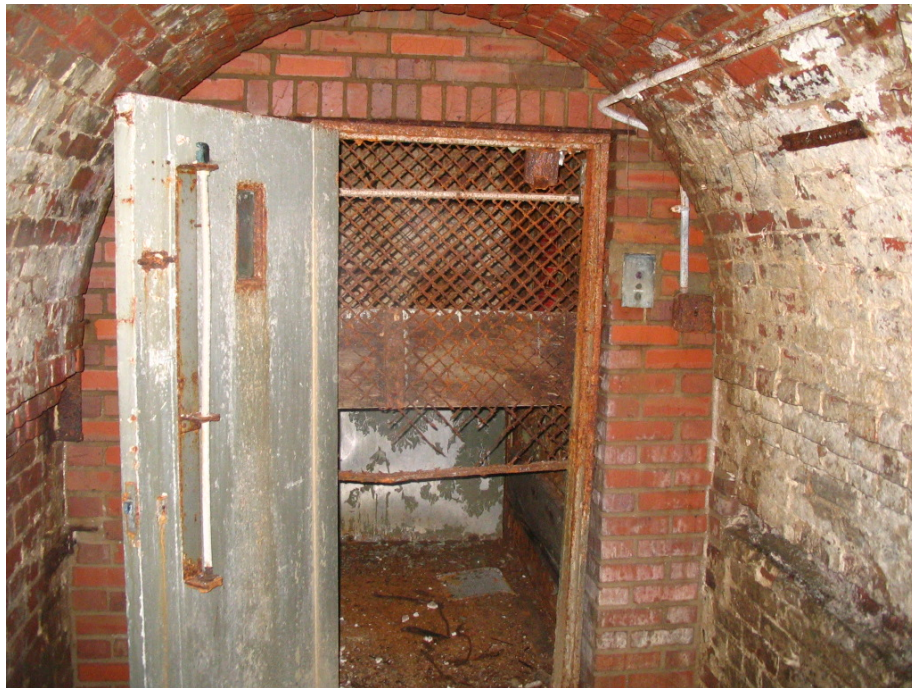
Photo 6: General view of elevator shaft to Building 34, east side

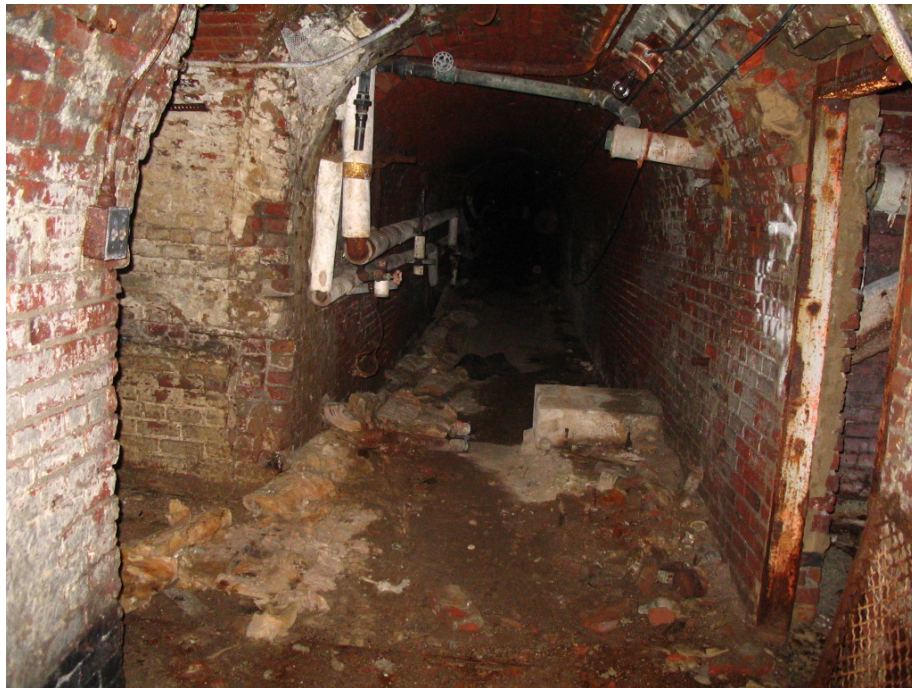
Photo 8: General view, looking south from Building 34

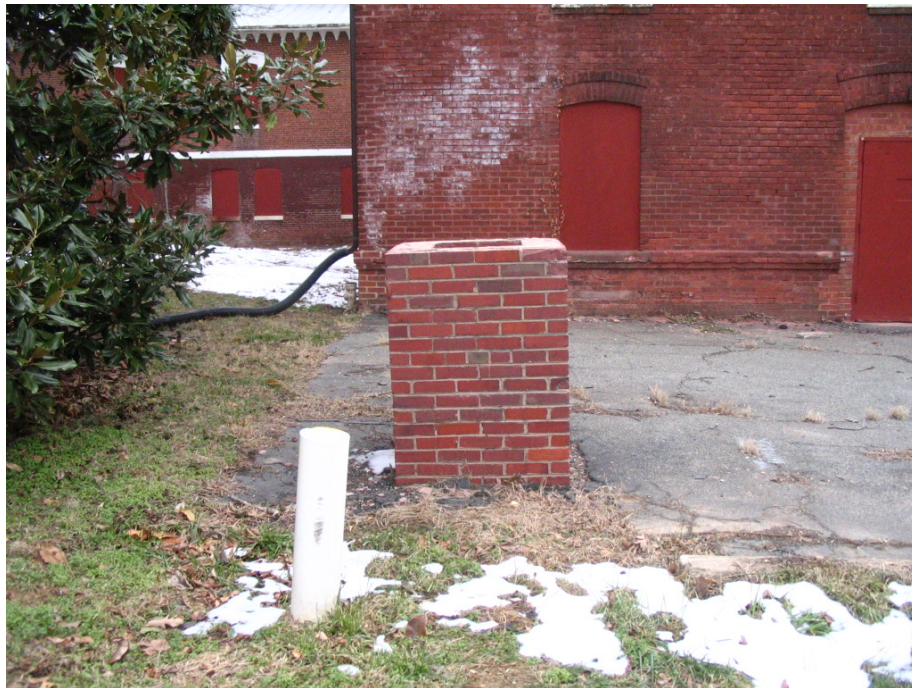
Photo 12: Vent to tunnel, Building 34 in background

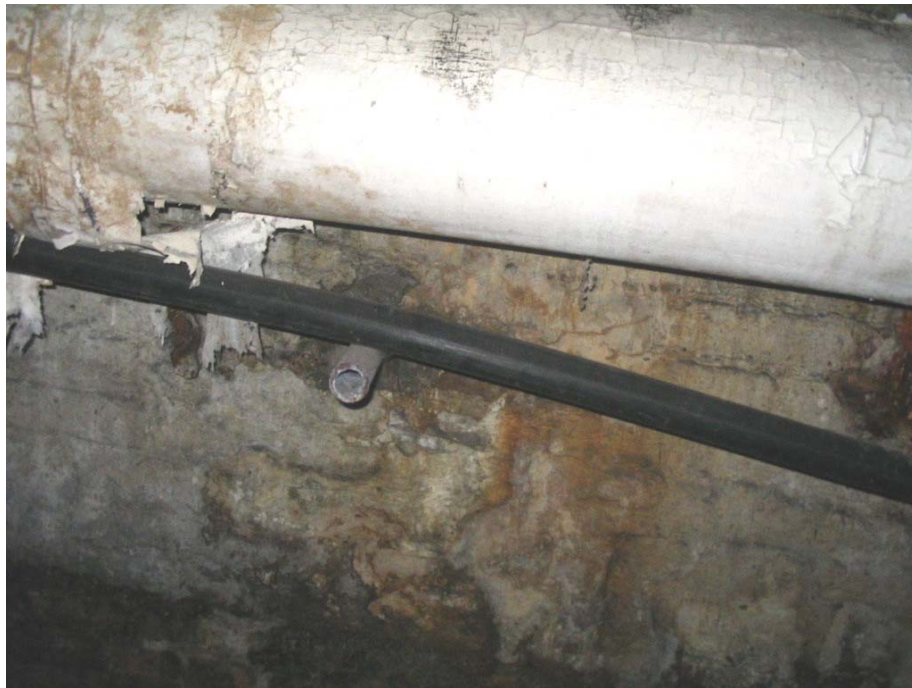
Photo 8: Typical support for telephone cable, south wall

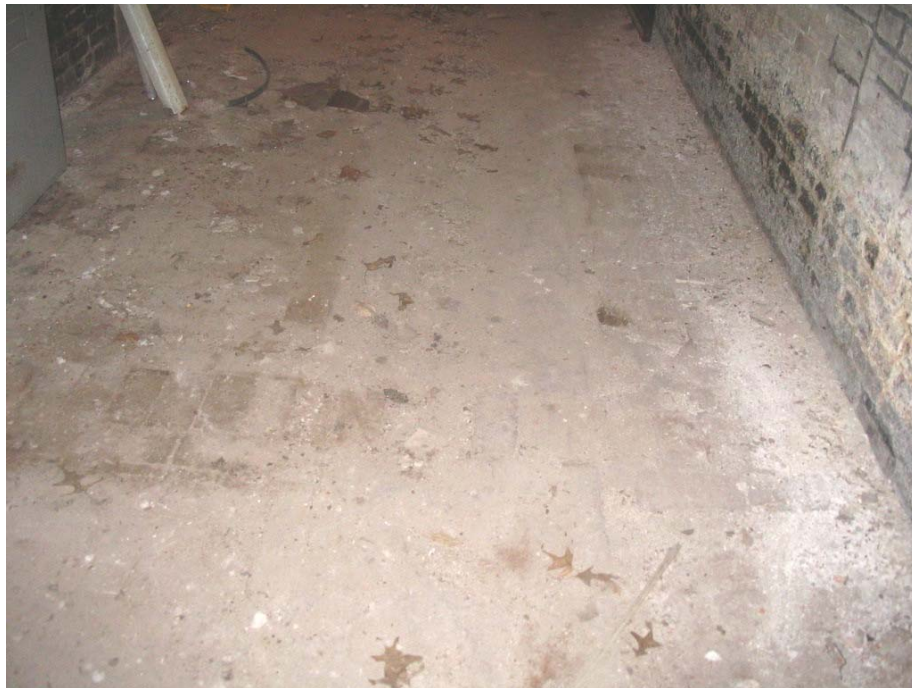
Photo 4: Remnants of tile floor covering track bed
